FIGURE **Ö**GEOHYDRAULIC CROSS SECTION: LAKE ST. CLAIR TO NISQUALLY REACH
NISQUALLY TRIBE/WATERSHED PLAN/WA

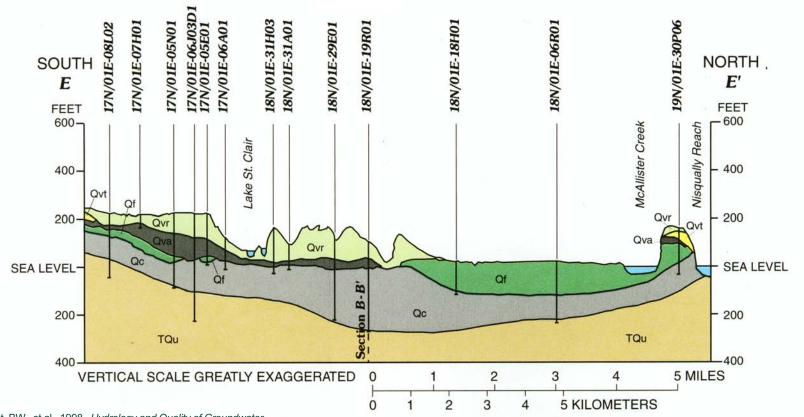
SOURCE: Drost, BW., et.al., 1998. Hydrology and Quality of Groundwater in Thurston County, Washington. USGS Water Resources Investigations Report 92-4109. Figure reproduced from: Well Locations, Surficial & Geohydrology, and Geohydrologic Sections - PLATE 1.
